## Ring Artefacts in CT Scan: A Red Herring

The computed tomography (CT) scan is an indispensable part of modern medical practice. However, the images are sometimes prone to artefacts, which may confuse the clinician. One such artefact is described here in details along with the diagnostic pitfalls of misinterpretation.

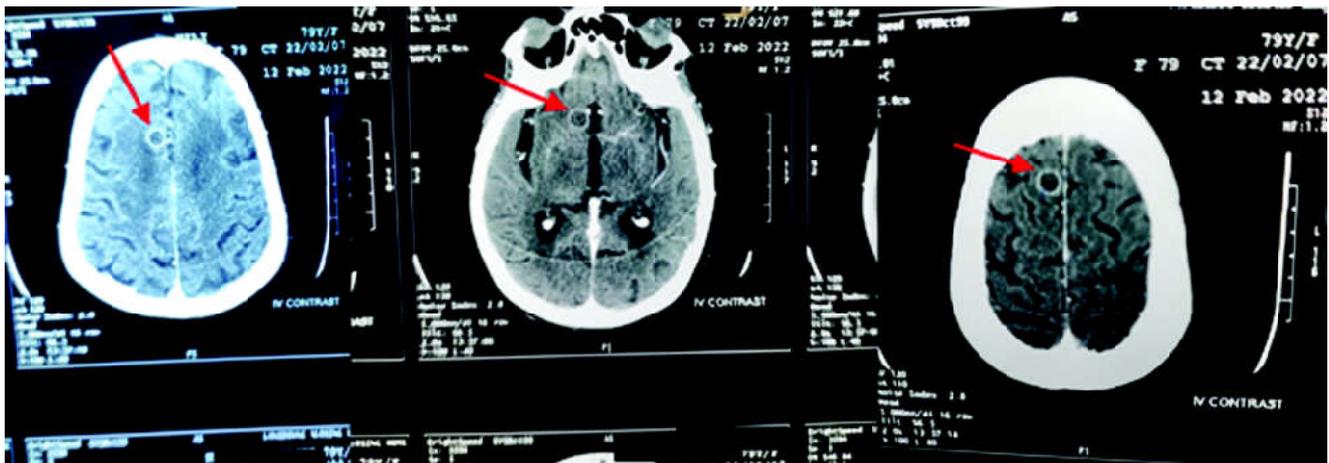
Fig. 1: CT brain of the patient showing ring artefact (Red arrows) in different axial cuts of the brain, simulating neurocysticercosis.

unconsciousness following fever. There was no history of convulsion. A non-contrast CT scan done at admission showed multiple ring-like lesions in different parts of the cerebral cortex (Fig. 1). The treating clinician was thinking of neurocysticercosis and a decision was taken to start the patient on anti-helminthic drugs. However, consultation with the radiologist revealed these "lesions" to be nothing more than ring artefacts which were due to some problem with the detector of the CT machine. Meanwhile, the patient's serum sodium levels were found to be 116 mEq/l and correction of that level led to regaining of consciousness. Thus, unnecessary treatment was avoided.

Ring artefact is caused by a miscalibrated or defective detector which creates a bright or dark ring around the centre of rotation<sup>2</sup>. Such artefact can be easily recognised and ignored in imaging of other parts of the body. But in brain CT scan, if of small size, it often simulates pathology like neurocysticercosis or toxoplasmosis. The artefact can be seen either as a full circle or as an arc. *The main clue in detecting this artefact is its presence in the same geometrical location in multiple sequential images*<sup>3</sup>. As seen in our case, the "lesions" were present in multiple sections of the brain, but if observed closely, they were all in the same relative position (Fig. 1). Normal brain pathology would not have this symmetrical appearance.

To eliminate this artefact, the detector needs to be

recalibrated or replaced. Sometimes, software-based correction is also possible.
